## U.S. Environmental Protection Agency Vasquez Boulevard I/70 Superfund Site Replacement Certificate

Property Owner	Charmaine and Mark Garcia
Property Address	3718 Race Street
Property Identification Number	896

## **Property Check-List**

This spreadsheet performs screening level calculations to estimate the effect of peeling leaded paint on the average concentration of lead in yard soil 3718 Race St.

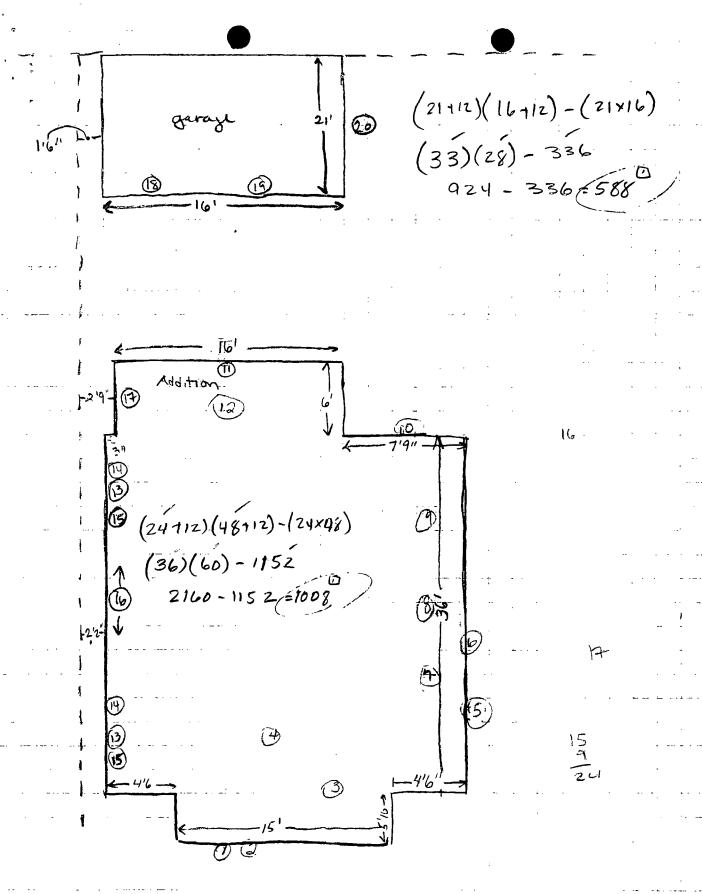
3718 RACE

3718 Race St.		Structure:	House			1	1				
8/10/2005		Direction:	West	T					1		
CM & WH MW								<del>                                     </del>			
11:00 a.m.		<del>                                     </del>	<u> </u>					T		1	
	Photo				Total Area of Element	Percent	Deteriorated Area (units		VDE V-I

Drawing Number	Number	Painted Surface	Material	Color	(units ft^2)	Deteriorated	ft^2)	XRF#	XRF Value	pos/neg	Notes
		Front Porch			İ					Į.	,
		downspout &			40.07			477	0.00.004		1
		gutter	Metal	Beige	16.67	n/a	n/a	177	0.39±0.21	Neg	
		front porch						1.74	0.07.0.40	l	
		capstones (2)	Stone	Brown	7.50	100%	7.50	171	0.07±0.16		
1	1		Wood	Beige	34.67	100%	34.67	See 172	21±7.8	Pos.	<del></del>
	_	Front Porch				140004	50.47	170	04.75	_	1
2	2	Beams	Wood	Beige	53.17	100%	53.17	172	21±7.8	Pos.	<u> </u>
		Front Porch		_							
		Railing	Stone	Brown	6.25	50%	3.13	See 171	0.07±0.16	Neg.	1
_	_	Front window	ĺ		!	1				_	
3	3	Frame & sash	Wood	Beige	n/a	n/a	0.39	173	2.7±0.9	Pos.	-
	1	Soffit/fascia/							!		
4	:4	dormer trim & walls	Wood	Beige	72.00	100%	72.00	See 172	21±7.8	Pos.	1
	1	1	1	1. 5	1		•				· · · · · · · · · · · · · · · · · · ·
3718 Race St.	1	Structure:	House			ſ				İ	
8/10/2005	<del></del>	Direction:	South						<del>                                     </del>	<u> </u>	1 1

Drawing Number	Number	Painted Surface	Material	Color	(units ft^2)	Deteriorated	ft^2)	XRF#	XRF Value	pos/nea	Notes
		Lower basement		T		1	† <del></del>	<del>                                     </del>			
5	5	window frames (2)	Wood	Beige	8.83	100%	8.83	See 173	2.7±0.9	Pos.	
)	6	fascia	Wood	Beige	27.75	50%	13.88	172	21±7.8	Pos.	
5		Soffit	Wood	Beige	45.00	100%	45.00		21±7.8	Pos.	<u> </u>
<del></del>	\ <del>-</del>	Window Frames					<del>                                     </del>			† <del></del>	
7	7	(2)	Wood	Beige	3.17	75%	2.38	See 173	2.7±0.9	Pos.	
		Window Frames		-0.30					+		
3	18	(2)	Wood	Beige	6.39	80%	5.11	See 173	2 7+0 9	Pos.	
	<del></del>	Window frame &		20.90		+	<del> </del>		2.7.20.0	<del>                                     </del>	
)	9		Wood	Beige	4.83	50%	2.42	See 173	2.7±0.9	Pos.	1
	<del></del>	gutter	metal	Beige		100%	15.00		0.39±0.21		<u> </u>
	<del></del>	igottei	metal	Deige	113.00	1 100 /6	110.00	1366 111	U.U3±U.4 1	1.4eg.	<del></del>

Drawing Number	Number	Painted Surface	Material	Color	(units ft^2)	Deteriorated	ft^2)	XRF#	XRF Value	pos/neg	Notes
		Window Frame &		1							
10	10	sash	Wood	Beige	4.67_	100%	4.67	See 173	2.7±0.9	Pos.	
		Addition window	}								
11	11	frame & wall	Wood	Beige	96.00	100%	96.00	174	38±11	Pos.	<u> </u>
		Gable end & soffit									
12	12	& fascia	Wood	Beige	212.00	100%	212.00	See 174	38±11	Pos.	1 1
3718 Race St.	İ	Structure:	House	f	l	1	1	1	1	1	1
8/10/2005		Direction:	North	T				† · · · · · ·			
CM & WH MW			1	<u> </u>	1		<del></del>	<u> </u>	1	1

Drawing Number	Number	Painted Surface	Material	Color	(units ft^2)	Deteriorated	ft^2) `	XRF#	XRF Value	pos/neg	Notes
		Lower basement					<del></del>	<del></del>		1	
13	13	windows (2)	Wood	Beige	5.89	100%	<sup>1</sup> 5.89	See 173	2.7±0.9	Pos.	
14	14	Window frames	Wood	Beige	5.83	100%	5.83	See 173		Pos.	
		Window frames						1			
15	15	smaller (3)	Wood	Beige	4.17	100%	4.17	See 173	2.7±0.9	Pos.	
16	16	Fascia	Wood	Beige	27.75	50%	13.88	See 172	21±7.8	Pos.	
16	16	soffit	Wood	Beige	45.00	80%	36.00	See 172		Pos.	
17	17		Wood	Beige	66.00	100%	66.00	See 174	38±11	Pos.	
		Gutter	Metal	Beige	15.00	100%			0.39±0.21		
3718 Race St.	I	Structure:	Garage	ļ.	1	I		1	1		*** ***
3/10/2005		Direction:	N.S.W.	<del> </del>	<del>                                     </del>	1		<del> </del>	<del> </del>		<del>                                     </del>
CM & WH MW				<del>                                     </del>		<del> </del>	<del></del>	<del></del>	+	<del> </del>	<del>                                     </del>
